September 1966 THE NAVAL AVIATION SAFETY REVIEW

Emergency Abort

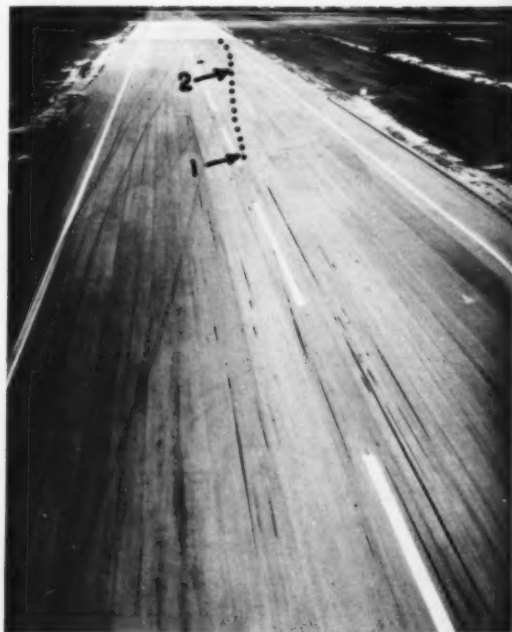
The A-5A arced to the post as the tire blew. . .

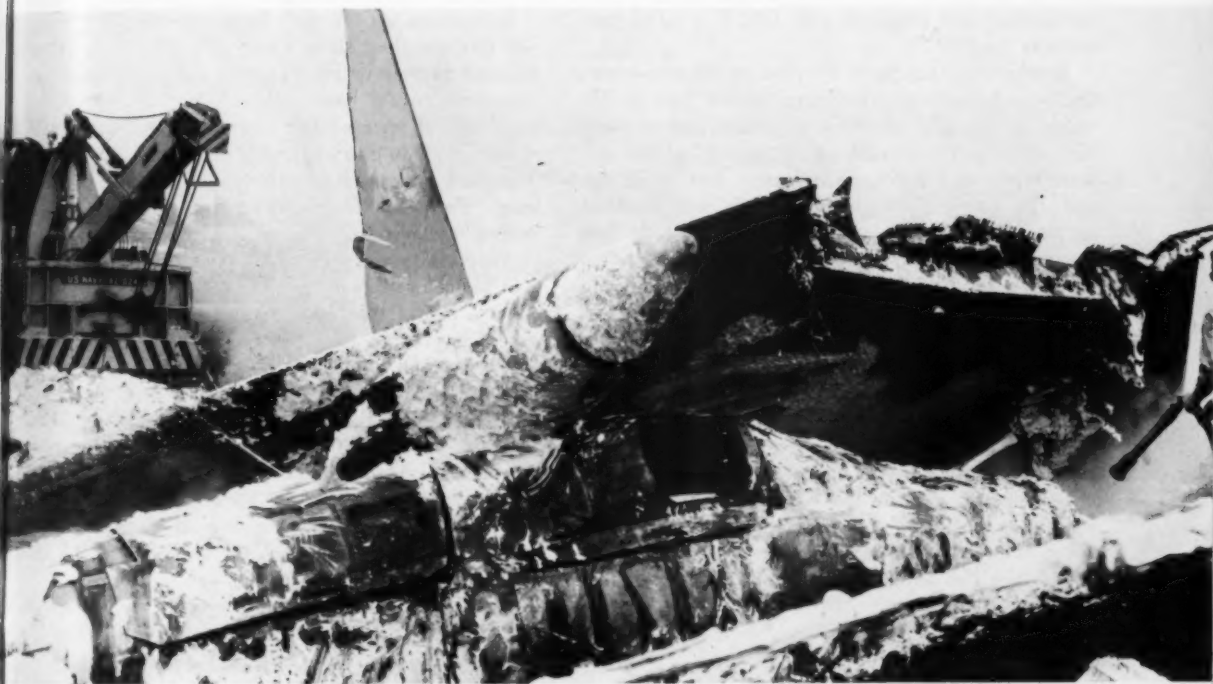
...the port gear sheared as it struck a mound of earth...

The wing snapped up and over the fuselage . . . fire consumed the wreckage.

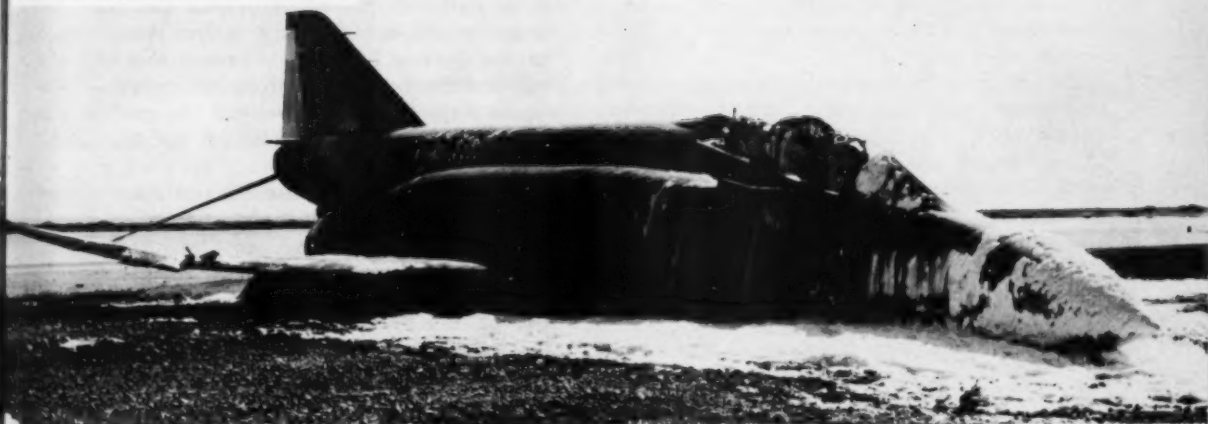
The starboard strut sheared as it passed over the chain. Burning JP-5 trailing, enveloped the F-4B as it slid to a halt.

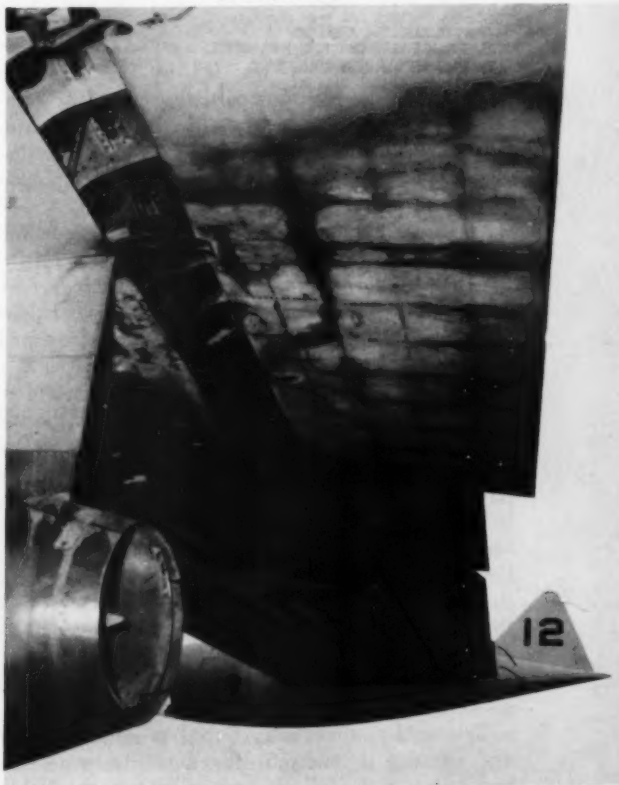
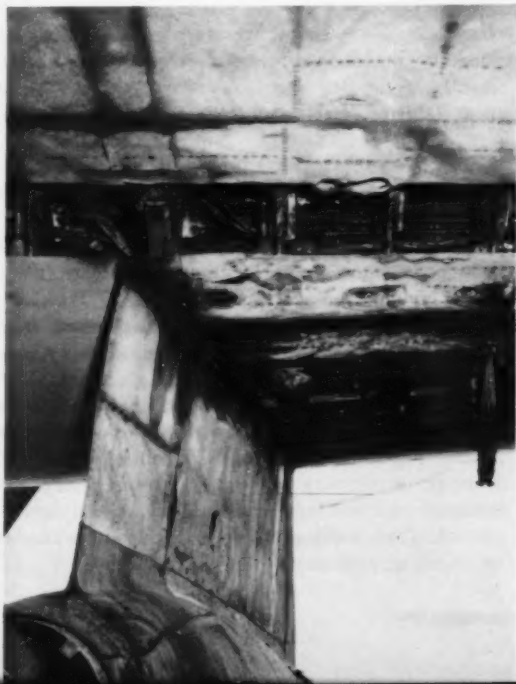
When the compressor rotor disintegrated, super-heated metal tore into the fuselage and surrounding areas. Fire broke out in the J-34 pod area.

The primary cause of this flight incident, unknown to the crew at the time, was the disintegration of the second stage compressor rotor of the starboard jet engine, which led to complete failure of the engine and started the ensuing fire.

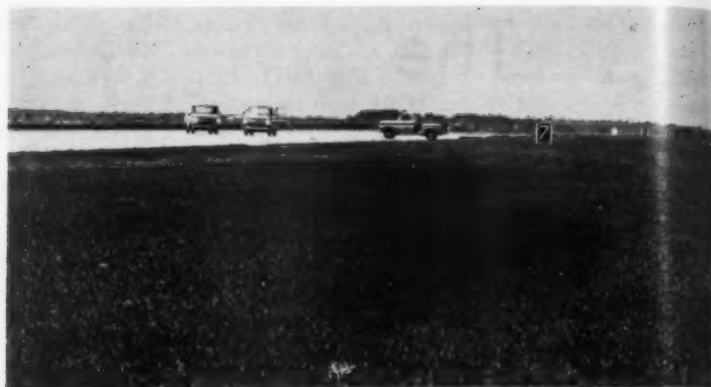
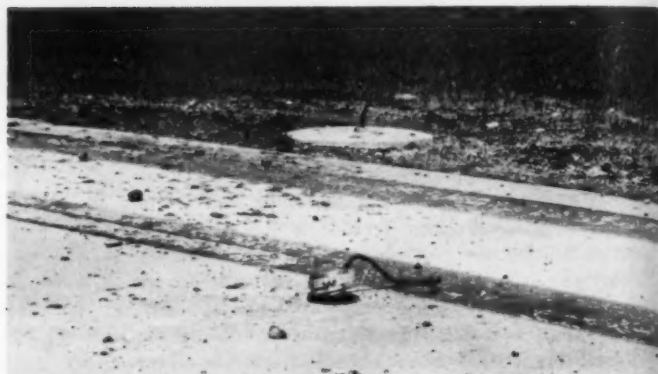
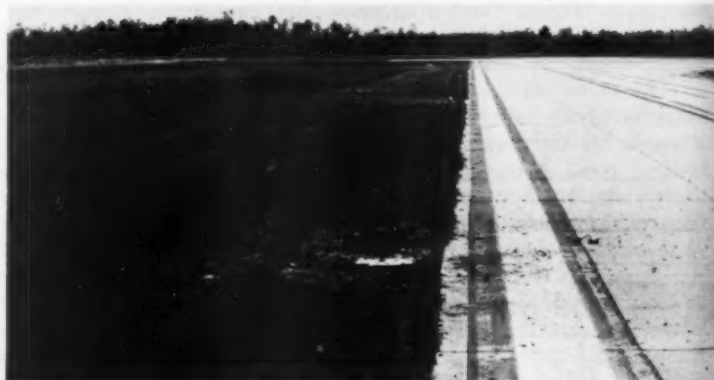
Some wheel tracks and a scorched path—

and in the grass a broken runway edge light

verifies a very close call.

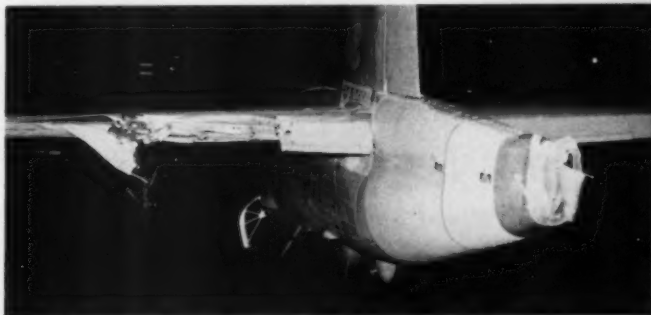
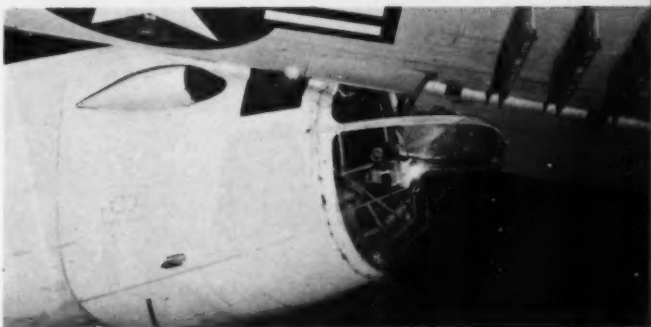
Buno 123456 finally came to rest with the trailing edge of its starboard wing buried in the nose of another P-2.

With frantic bursts of power the brakeless *Neptune's*

back and forth sequence became more violent. . .

- Always placard an aircraft whenever a system is incapacitated.
- Pass the word, in writing, on job turnover. Remember, two-way communications within the maintenance department is necessary for flow of information up and down the chain to keep Maintenance Control informed of work in progress.
- Preflight for turnups—use the NATOPS checklist.

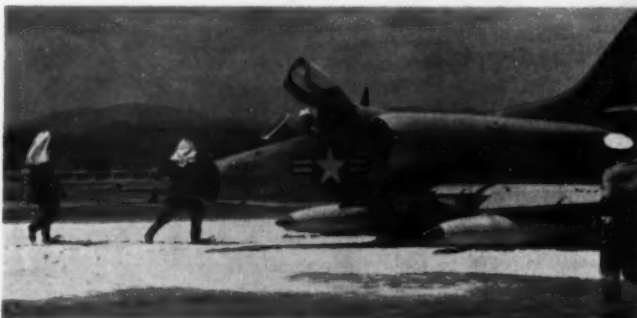
Crud in up-and-down sequence valve prevented extension of landing gear.

Cleanliness during maintenance is a must to avoid hydraulic system contamination.

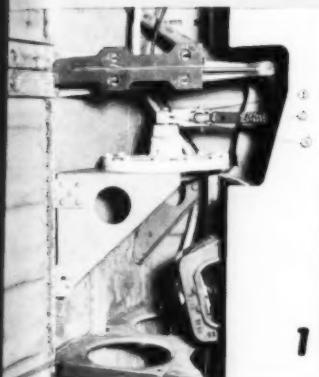
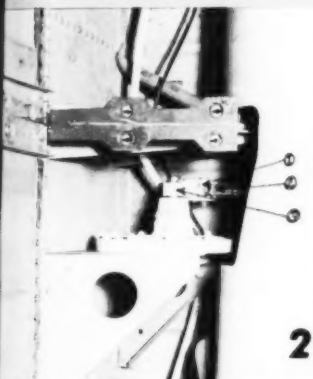
Photo 1: Rudder, full right. Arm (3) installed 180 degrees from normal position allowing viscous damper arm (2) to break guard plate (1). Photo 2: At full left rudder, damper arm (2) forced its way through guard plate. Photo 3: Arm (3) correctly installed. Viscous damper arm (2) cannot make contact with guard plate (1).

* If an aircraft part can be installed incorrectly, someone will install it that way!
